# Efficient and economical retrofit

In 1999, JG Smith Construction commenced maintenance and service repairs on metal roof systems at the Mills Pride complex in southern Ohio. Professional roof inspections were executed to ascertain the current condition of the system components. The report categorized roof system conditions in three categories: currently maintainable, repairs needed to achieve a level of maintainability, and recommended replacement due to oxidation and severe deterioration. Several buildings fell into the third category, and recommendations for near term replacement were proposed.

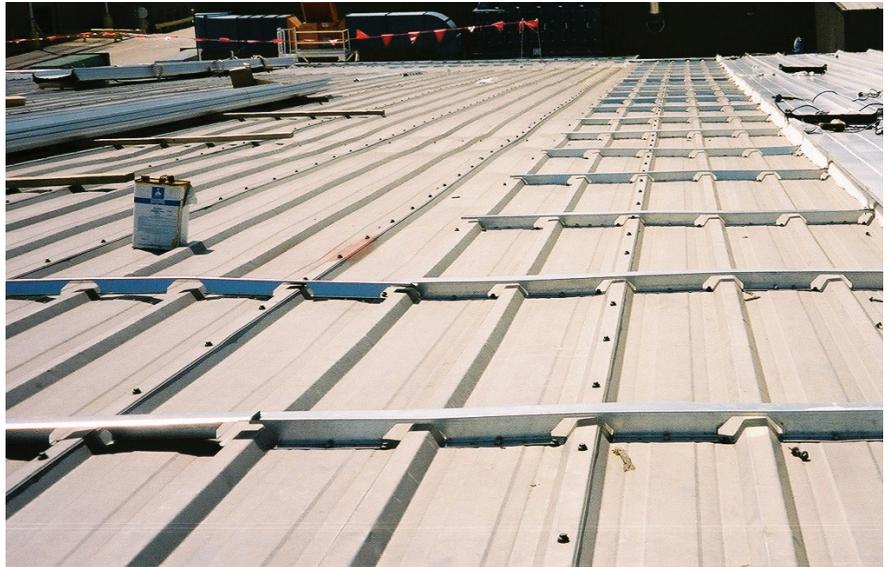
*JG Smith Construction tried different methods of installation, but found the Roof Hugger to be the most efficient metal roofing retrofit system for its uses at the Mills Pride furniture manufacturing complex in Waverly, Ohio. JG SMITH CONSTRUCTION PHOTOS*

This spring, Mills Pride awarded a second roof retrofit project to JG Smith for the Washington building. This 110,000-square foot facility had many of the same rusting and deterioration problems as the Lincoln building. To eliminate the same expensive mistake incurred during Lincoln building roof retrofit project JG Smith went with the Roof Hugger retrofit support system, a lightweight heavy gauge framing system which installed over the existing purlin structure. The Roof Hugger eliminated high rib interference, and provided for the reestablishment of panel-to-purlin clamp loading, and the subsequent enhancement of structural integrity. ■
