RETROFIT ROOF DESIGN AND TESTING – YESTERDAY AND TODAY

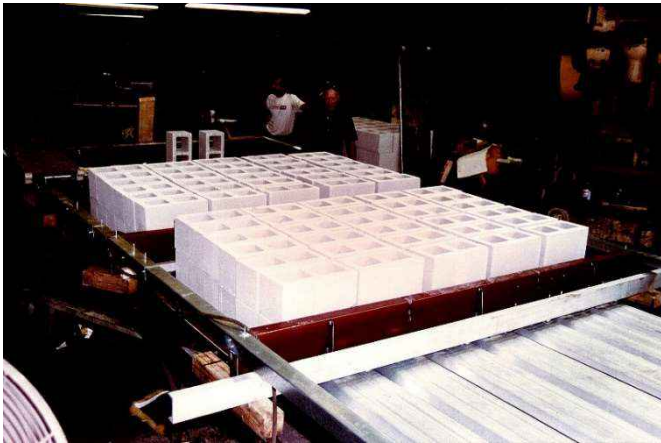
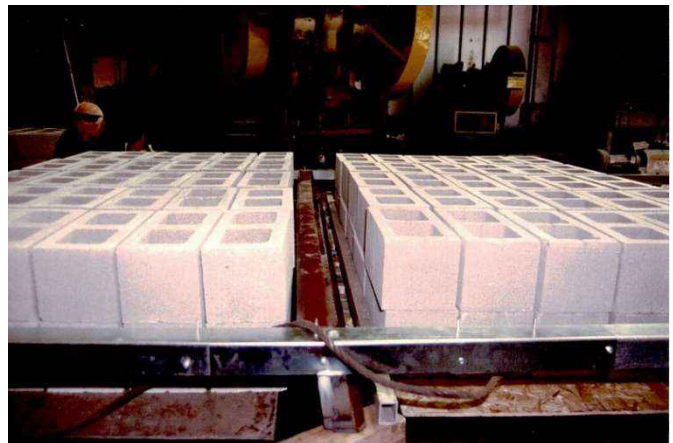
Let’s build a roof section, he said, turn it upside down and stack concrete blocks on it until it collapses. We weigh the blocks, and then we’ll know at what load the system fails. Great idea we thought so off we went to create a mockup and test it. The system didn’t perform quite like it calculated but we had some actual data points!

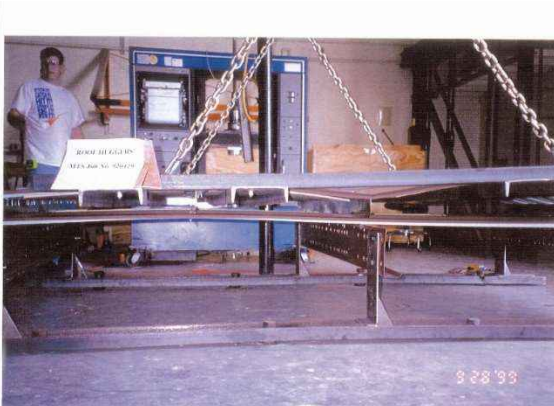
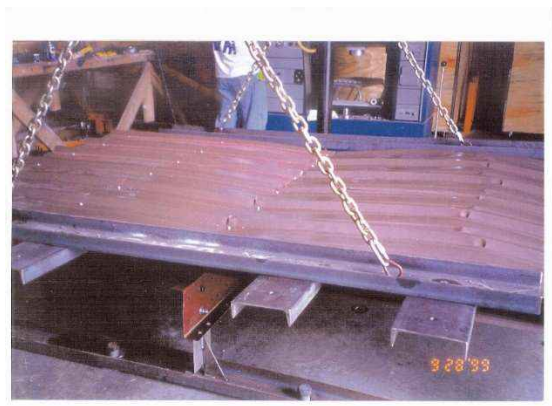
By the late 90's test labs were getting more sophisticated. The Celotex Test Lab Facility in St. Petersburg, FL recommended a then precise protocol for uplift performance and we did some additional confirming tests, using the latest equipment. Now we had even more data points to compare to our early rudimentary testing.

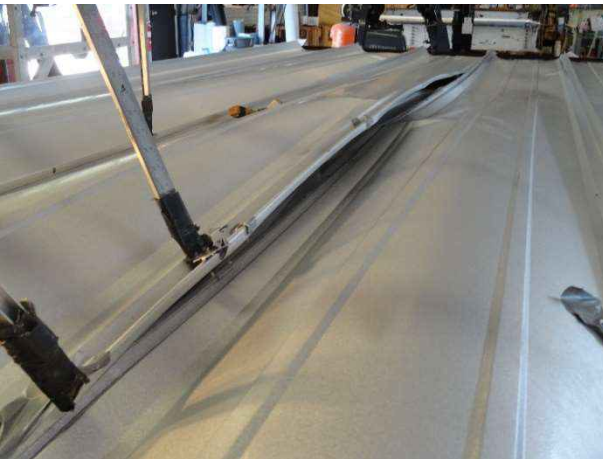
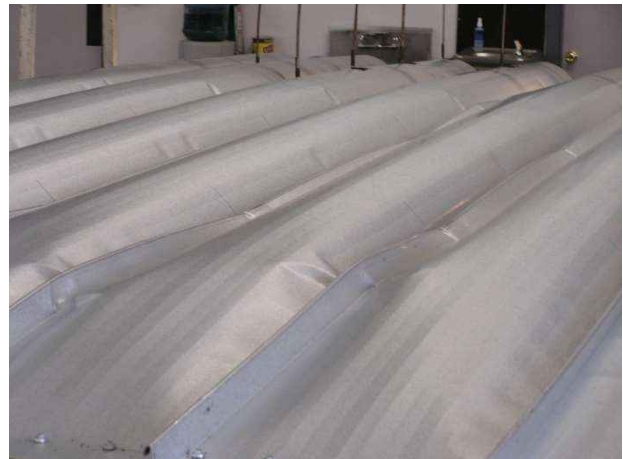
In the early 2000's a new test was becoming the industry standard for testing and for code compliance. This new test was the ASTM E-1592. The E-1592 test was developed to test standing seam panels, although it can test both Screw-down and Standing Seam types. It basically places a flexible airbag beneath the panel and air pressure is gradually added to this airbag pushing the panel up until it fails. Very aggressive but, a reliable and repeatable test which soon became the industry standard.

This was the best test ever for our system because now we could have real performance test data with the sub-framing system and the actual new roof panel (or similar) in a real-world assembly. The testing confirmed what we had discovered from our earlier tests, that the systems do not test as well as they calculate. However, this was good news, since now we had industry-accepted performance data! The only problem was that there are hundreds of new and existing panels in the market. Fortunately, many panels are very similar and can be grouped for analysis, but a significant amount of testing still had to be conducted. With this knowledge, we set about the business of testing the major groups including screw-down roofs, Vertical rib Standing Seam, Trapezoidal Standing Seam, Deep Rib Systems, Tall Clip Assemblies, Corrugated panels, and more.

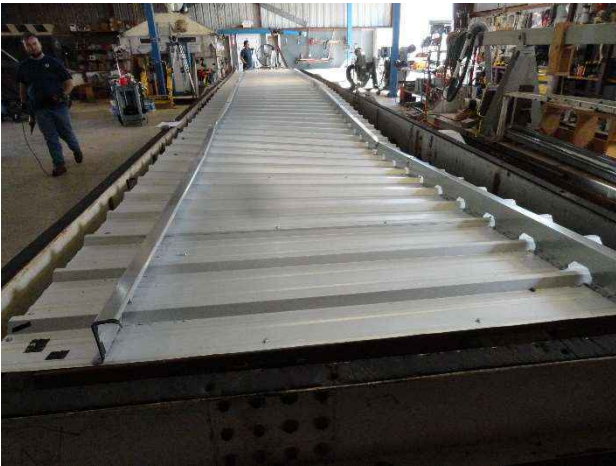
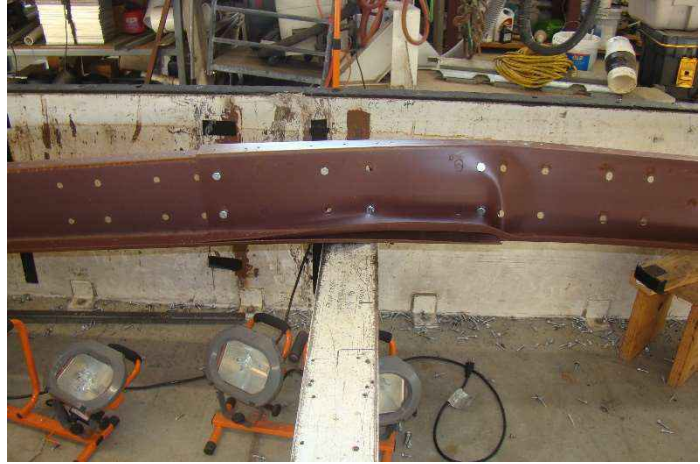
To address the issue of how the total system of the existing building purlins will perform after a retrofit we undertook the first-ever Base Testing of a retrofit system on continuous purlins. This required the construction of a 50' long chamber (2-25' bays) and combinations different height Roof Hugger Sub-purlins.

The results, confirmed by 2 additional structural engineering firms, has allowed us to create computer-based modeling that can analyze most existing metal buildings, their current capacities, and the capacity after retrofitting.

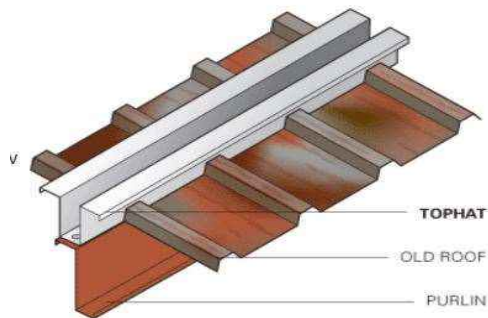
Competing products make claims of superior strength but fail to analyze the many other modes of failure such as buckling of the existing purlins, existing purlin lap failure, web crippling due to purlin deflection at the frames and other issues.
