When Is Coating a Metal Roof Not the Best Choice?

By Dale Nelson, President, Roof Hugger, LLC Retrofit Systems

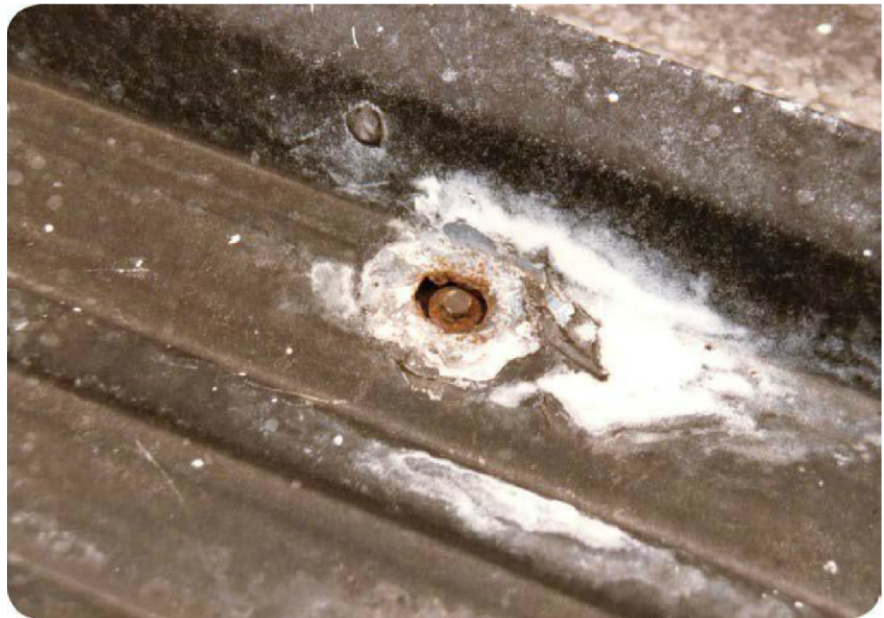
Photo courtesy of Roof Hugger, LLC

It is common to see some corrosion on older metal roofs, but when it is severe, you need to look more closely, particularly if the roof has been known to be leaking for an extended period of time.

be looked at carefully from inside the building as well as from outside on the roof. Long-term roof leaks can cause the structural purlins and/or eave struts to be reduced to something resembling Swiss cheese. If you see this, the building is structurally compromised, and a structural engineer with knowledge of metal roof/building systems needs to be involved. If the corrosion is severe and perforating of the roof

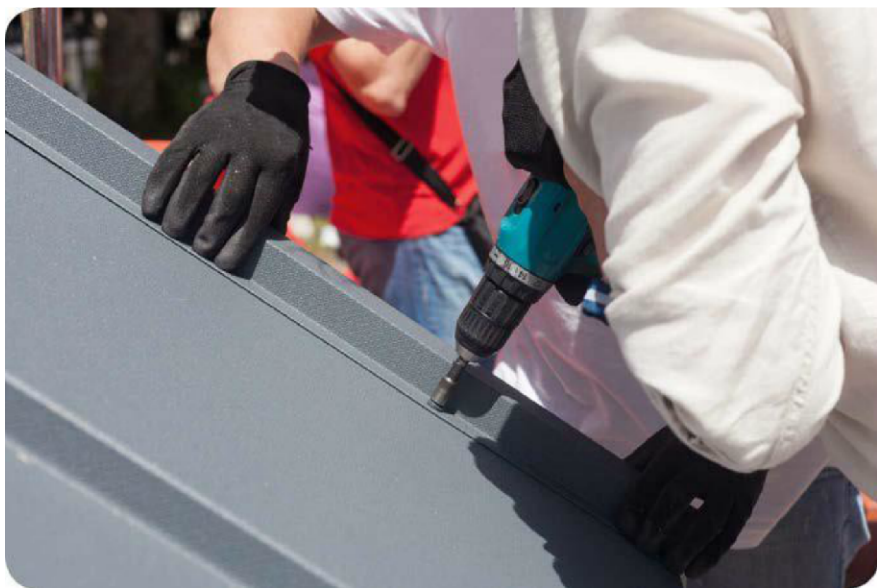
Leaky or badly corroded fasteners can also result in corroded weak areas in the roof panels immediately around the fasteners.

- **Fastener Problems:** Leaky or badly corroded fasteners can also result in corroded weak areas in the roof panels immediately around the fasteners. The fasteners not only hold the roof down, but they transfer critical diaphragm strength to the entire structure. A fastener cap will cover a structural defect but not correct it. The cap will not keep the roof on the building in a storm or transfer diaphragm loads to the structure. Improperly coating a compromised building will likely hide the problems, but it may also put you in the liability chain should a structural failure occur. Legally, you are a roofing professional and should be able to recognize when you need to seek additional expert advice.
