CORRU-FIT SYSTEM AT CORNER ZONES

ZF-05-CF
06.15.12

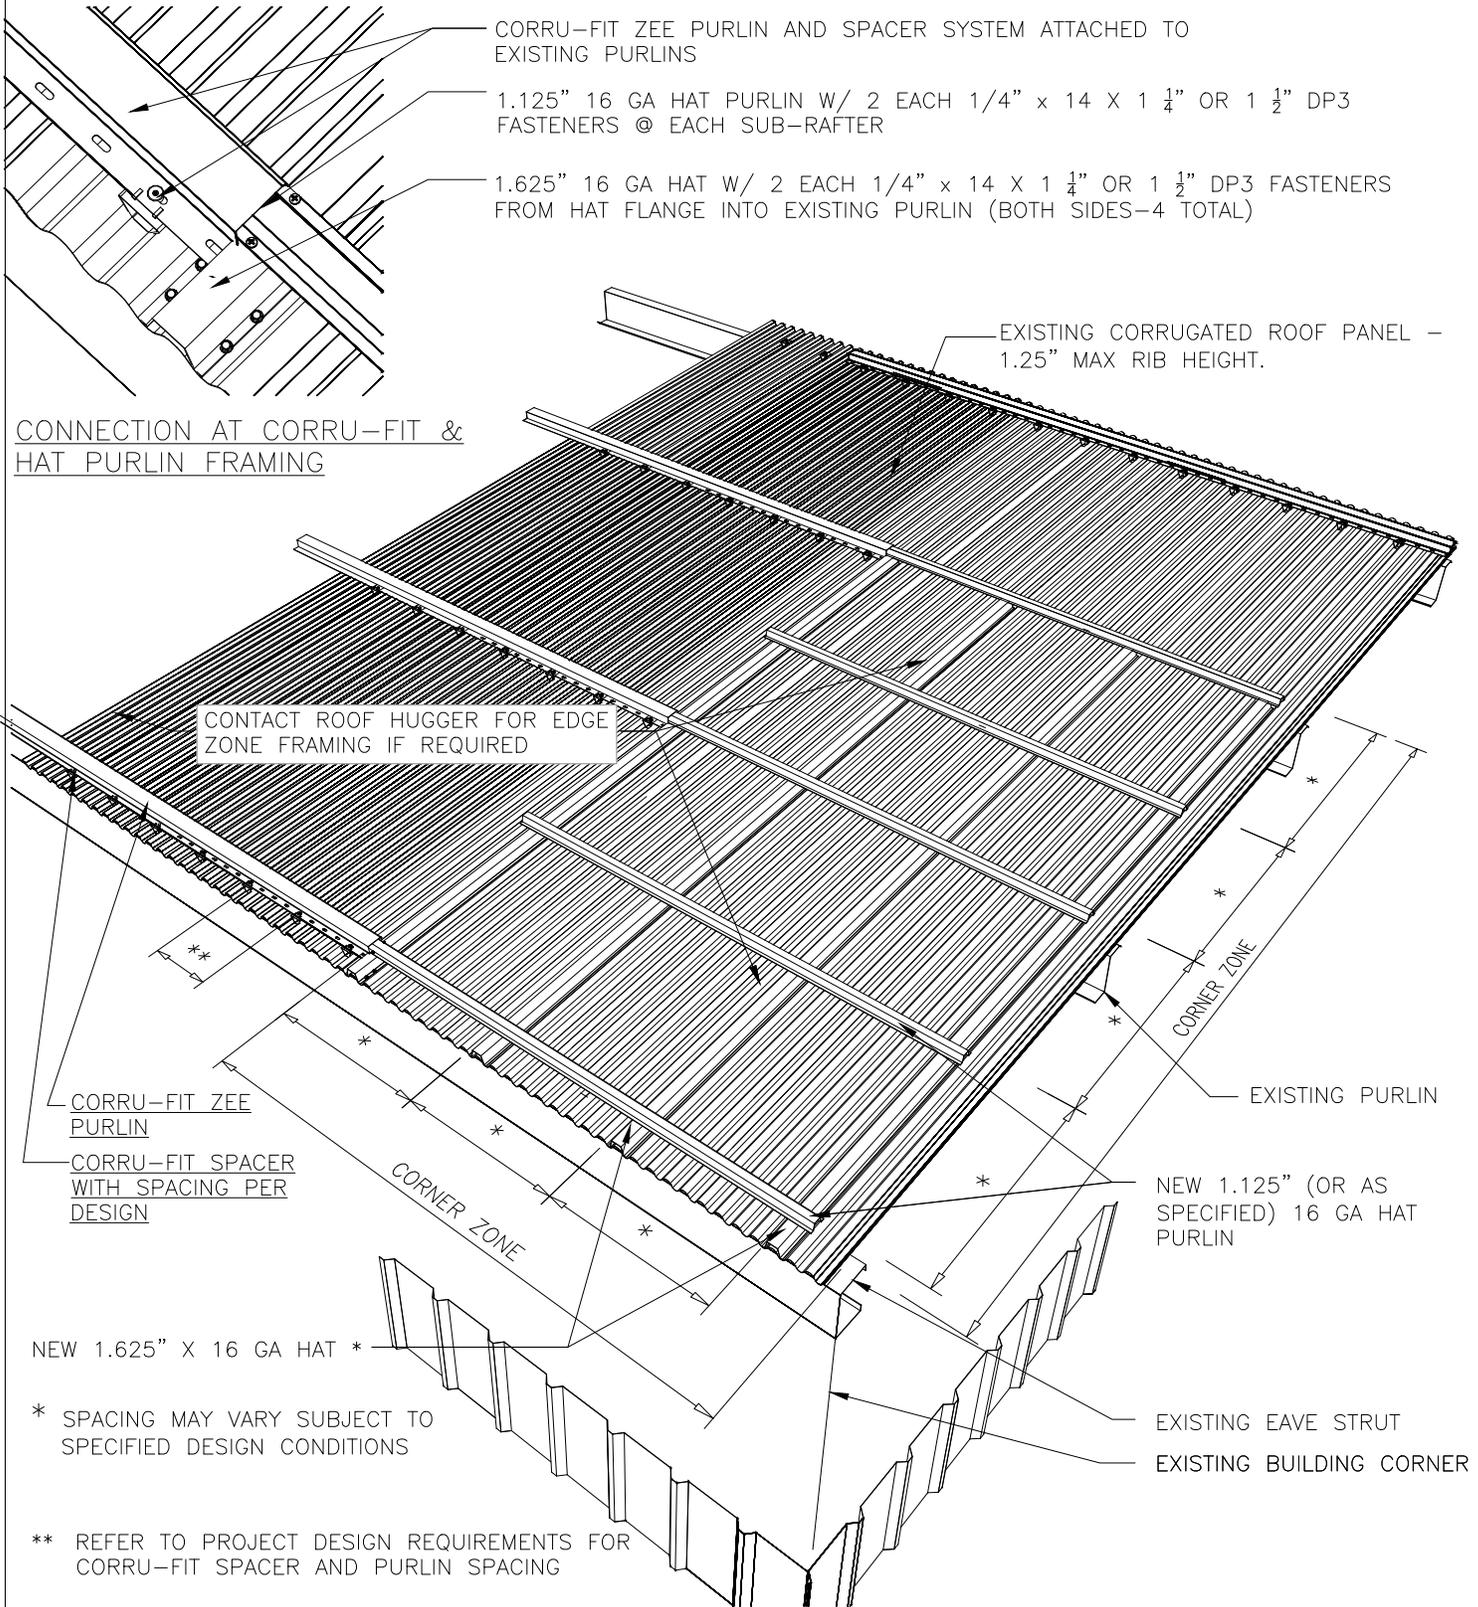
EXISTING CORRUGATED ROOF PROFILE
