NEW TRAPEZOIDAL SSR OVER EXISTING CORRUGATED ROOF PANELS

**CORRU-FIT ATTACHMENT**

**HA-13 TC/CF**

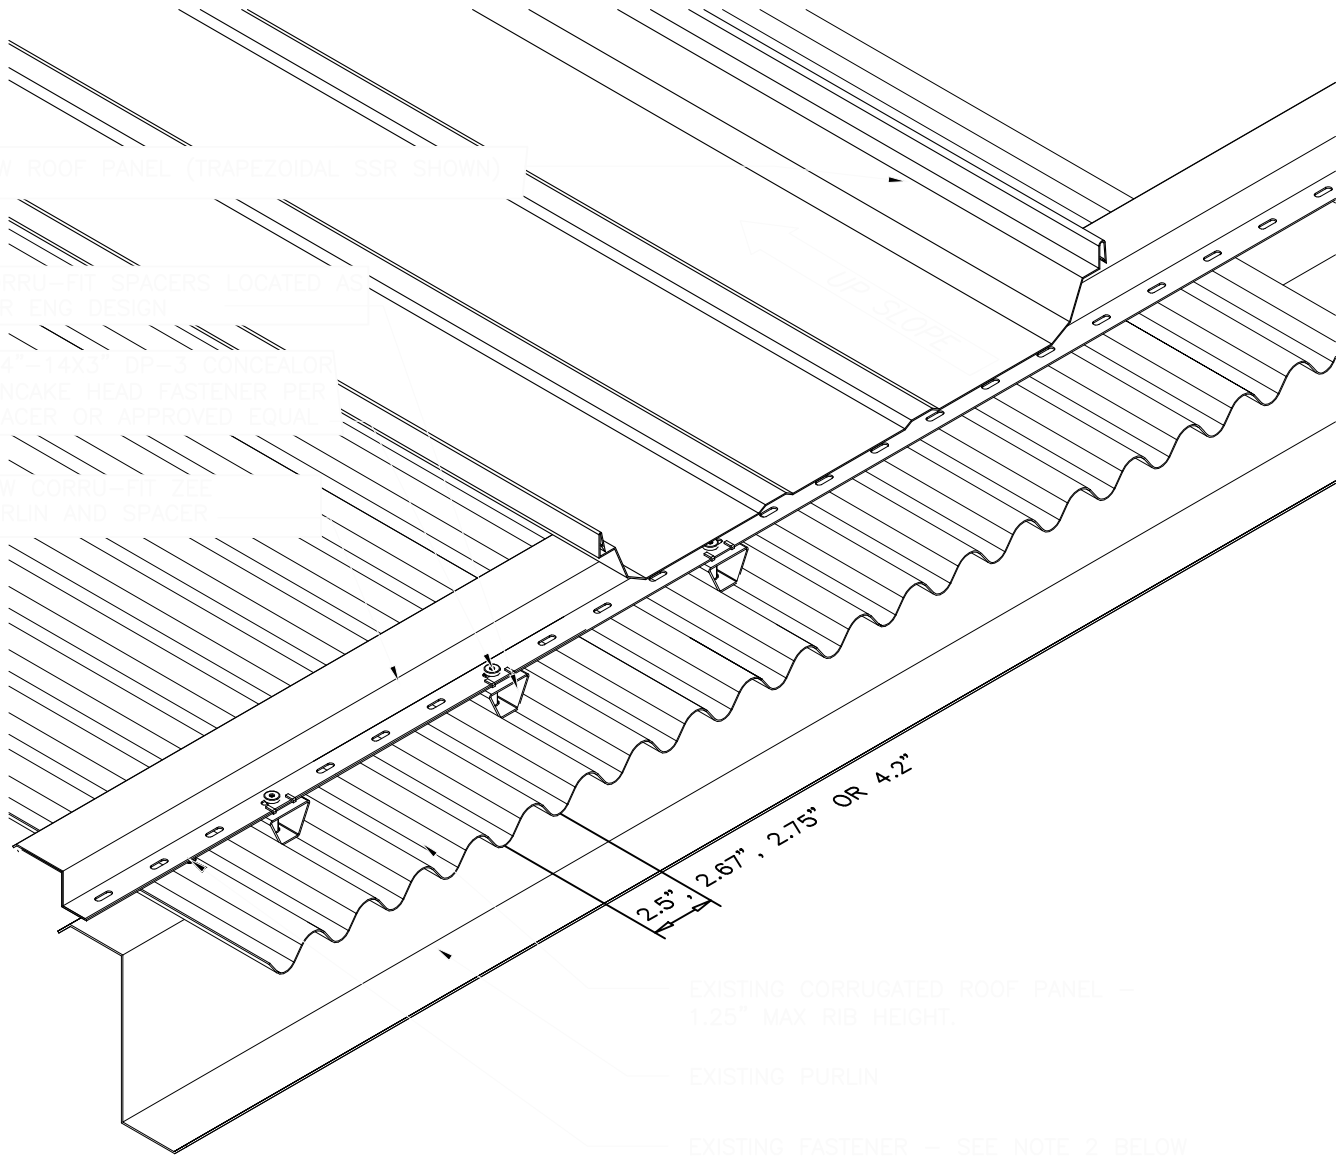
NEW ROOF PANEL (TRAPEZOIDAL SSR SHOWN)

CORRU-FIT SPACERS LOCATED AS PER ENG. DESIGN

1/4" - 1/4" DEEP CONCEALED PANCAKE HEAD FASTENER PER SPACER OR APPLIED EQUAL

NEW CORRU-FIT ZEE PURLIN AND SPACER

EXISTING CORRUGATED ROOF PANEL — 1.25" MAX RIB HEIGHT

EXISTING PURLIN

EXISTING FASTENER — SEE NOTE 2 BELOW
