ROOF HUGGER, LLC
 P.O. BOX 127, ODESSA FL 33556
 P: 800 771-1711
 F: 877 202-2254
 www.roofhugger.com

**SPECIAL PURLIN STRENGTHENING
 HUGGER LAP ATTACHMENT - 14 & 16 GA PURLIN**

HL-04-V
 04/15/2014

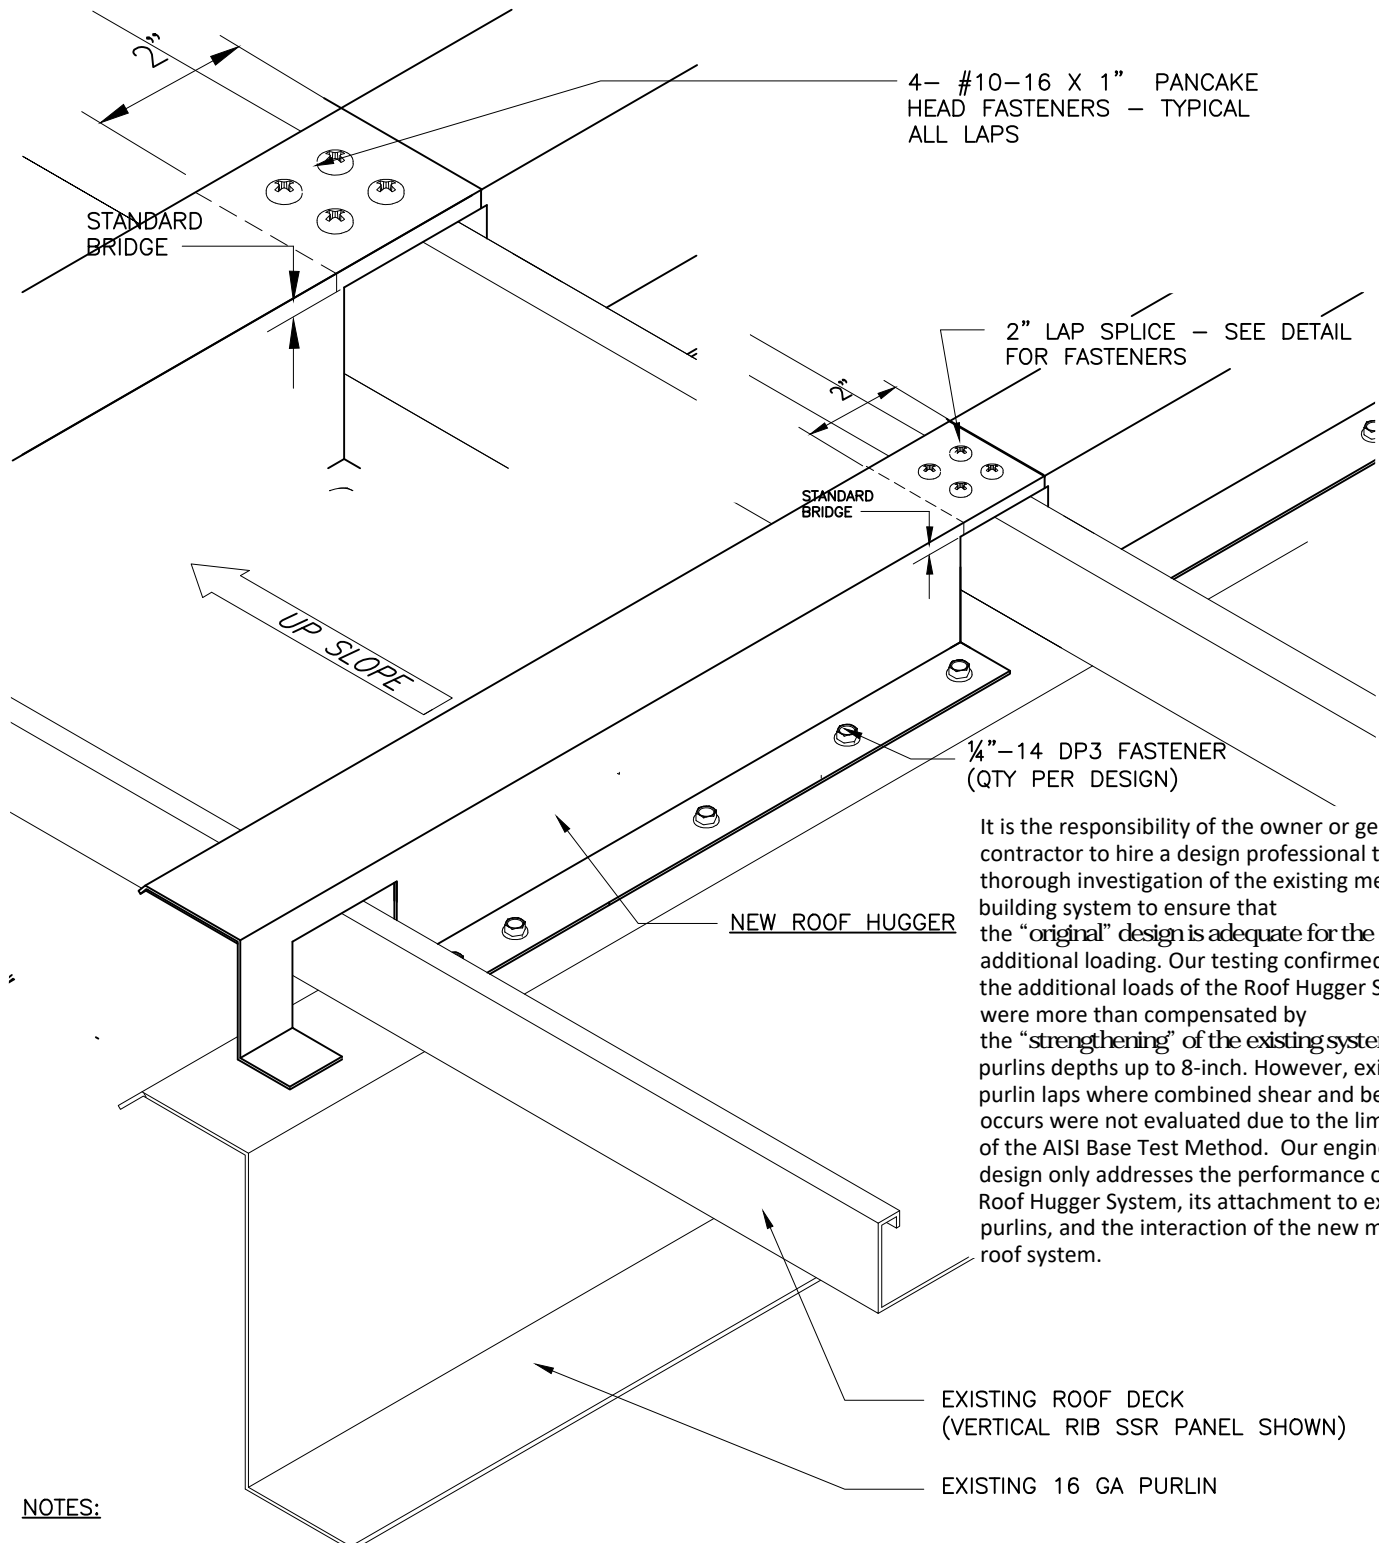
SCALE: 3"=1'-0"
