CORRU-FIT SYSTEM AT CORNER ZONES

ZF-05-CF
 06.15.12

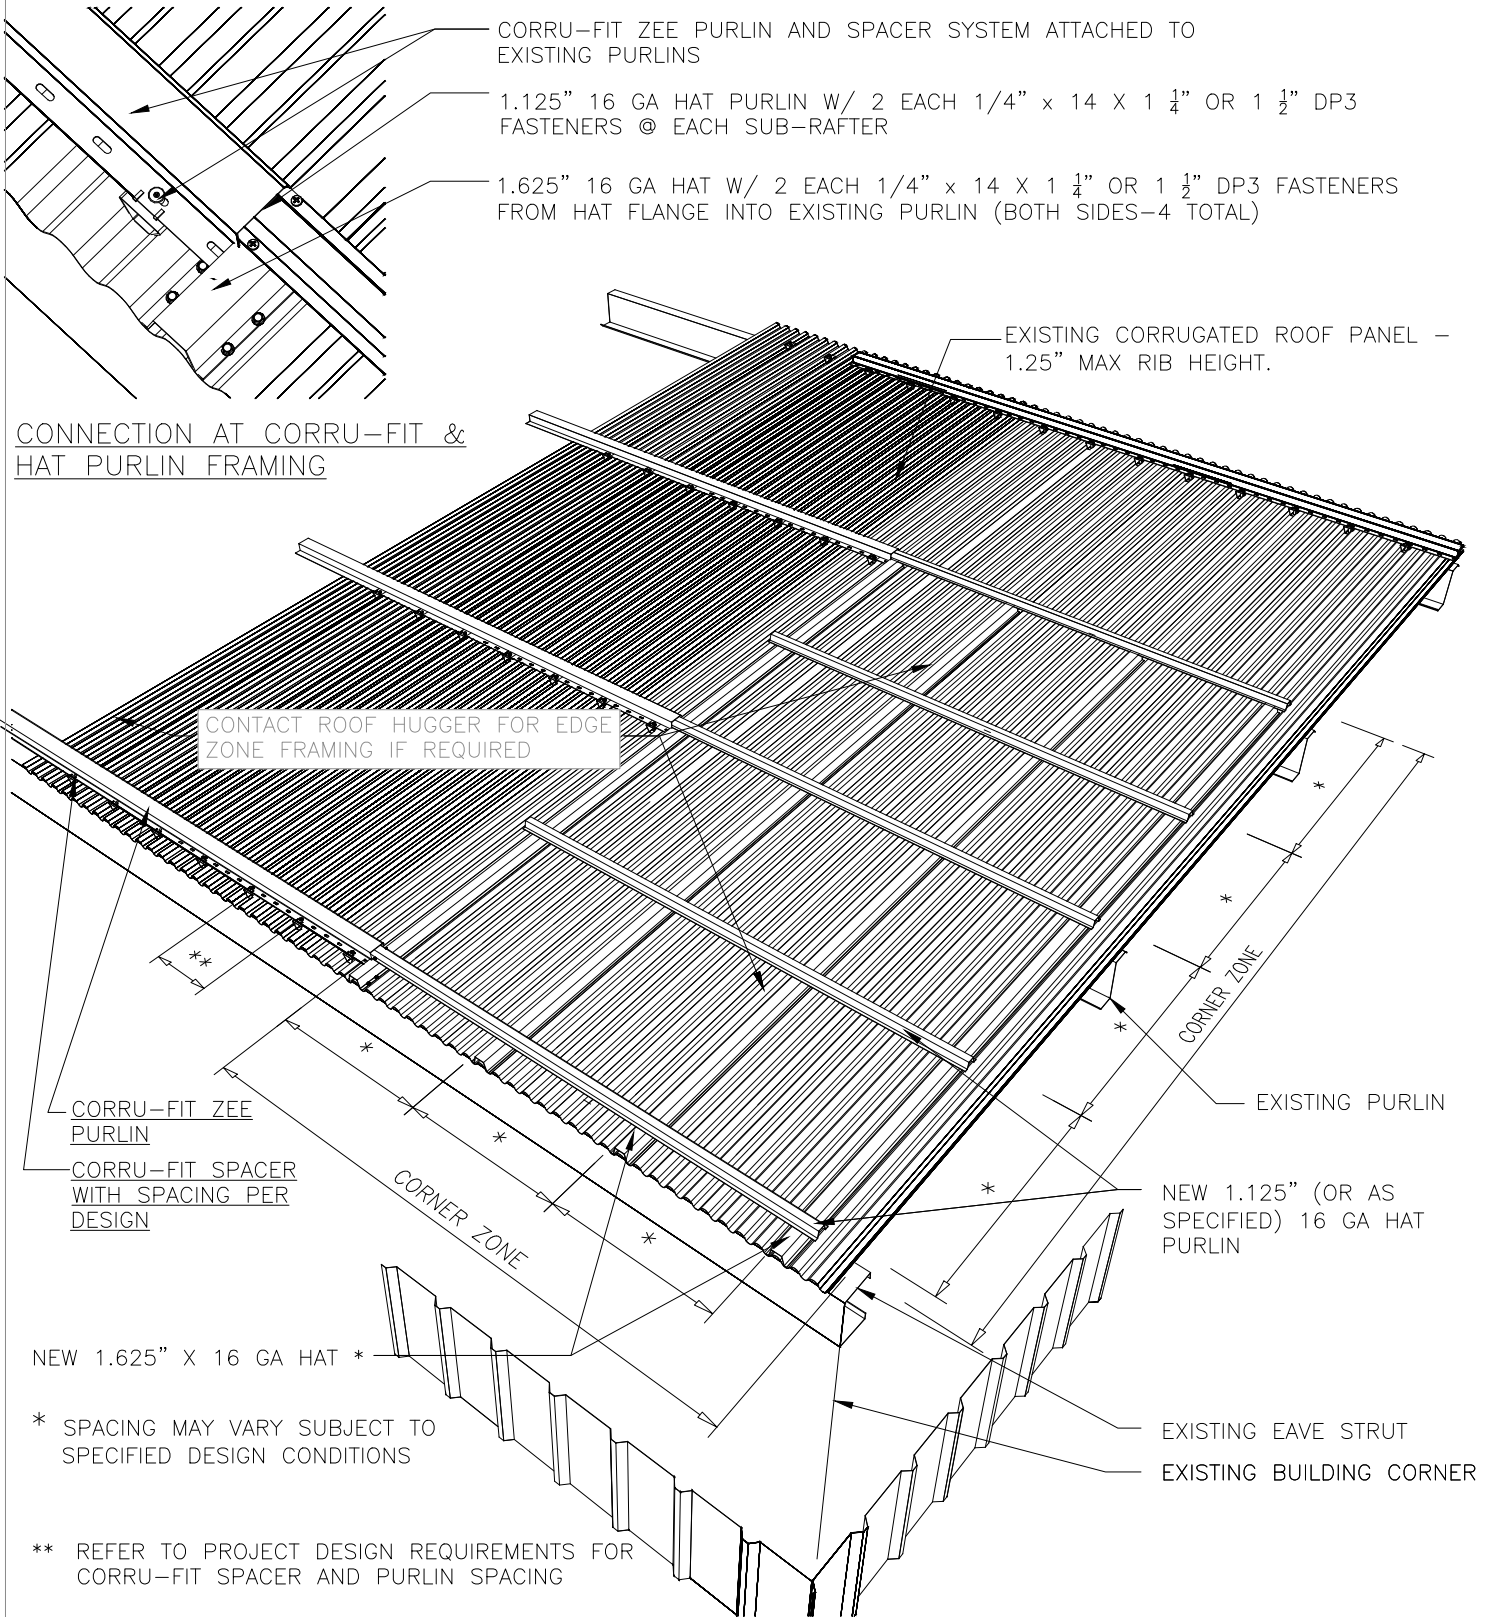
EXISTING CORRUGATED ROOF PROFILE
