## COATINGS – KNOW WHAT YOUR BUYING

### UNDERSTANDING METAL ROOF COATINGS:

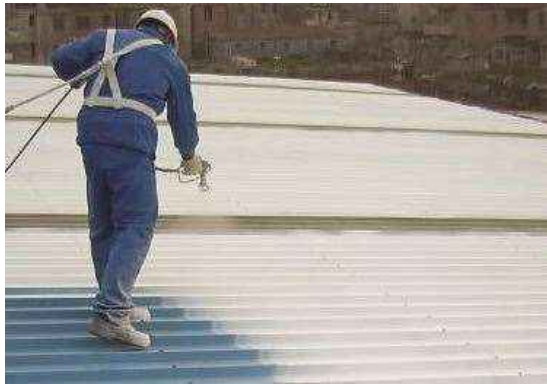
Spray applied Coating

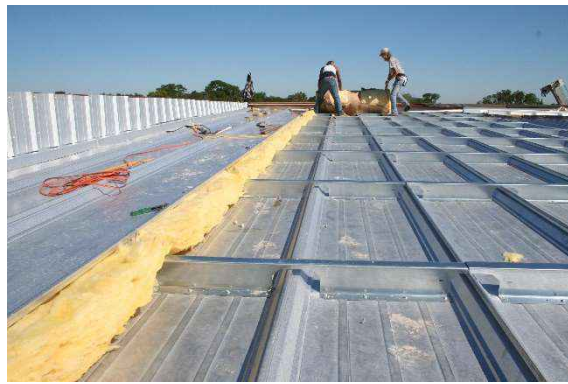
Metal over Metal Retrofit

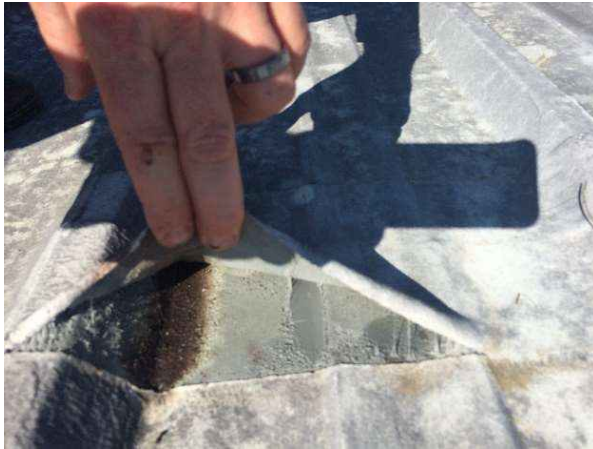
Like all coatings, the proper cleaning and prep of the existing roof is critical to getting a good result. Proper cleaning for good adhesion and a uniform spray application are difficult to achieve. (see photo) Pinholes, blisters, edge gaps and other imperfections are common.

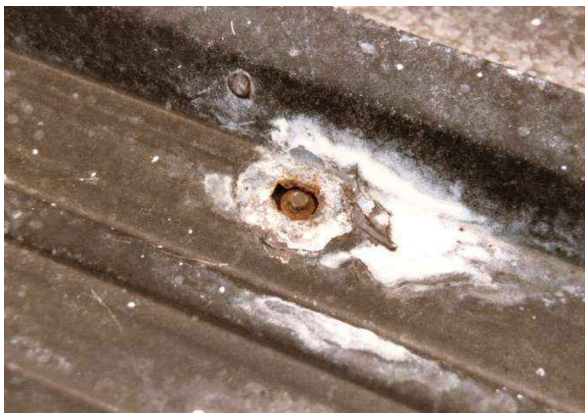
Fastener caps are frequently used to cover corroded fasteners and panel defects but can also hide the structural problems of loss of diaphragm strength and panel uplift. (see photo)
