On Island Time

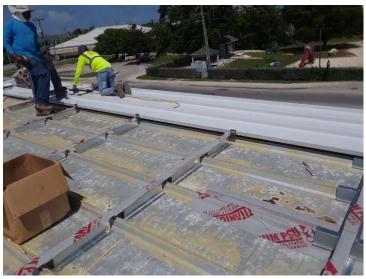
Precision Industries Cayman LTD, located in the city of Georgetown, on Grand Cayman was called in to do a metal roof retrofit for one of their customers. The main criteria of the job, was to make sure the new metal roof could withstand the strong winds of most hurricanes. Being familiar with metal roof retrofits, Precision knew who the "Go to sources" for this job would be Atas International for the coil to roll form the new roof panels on site, and Roof Hugger LLC, for the framing system to properly support that new roof.

With the building having an original 24" trapezoidal standing seam roof on top, they would need to use the Roof Hugger 4.5" tall Model-D sub-purlins, which would be structurally attached to each existing purlin, through the existing panel.

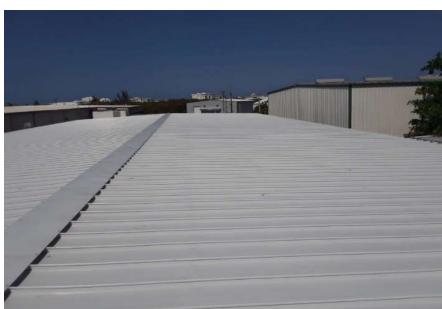
Finished Roof Ridge Finished Roof

system which allows for tighter clip spacing in the most vulnerable zones of the roof. That system consists of hat sub-rafters installed from purlin to purlin, at 2 ft o.c. spacing, and then the hat sub-purlins attached on top, running parallel with the eave to create clip attachments every 2'-6" in each corner of the building.
